Survey level two: HomeBuyer report - Survey

Stickens Lock Lane

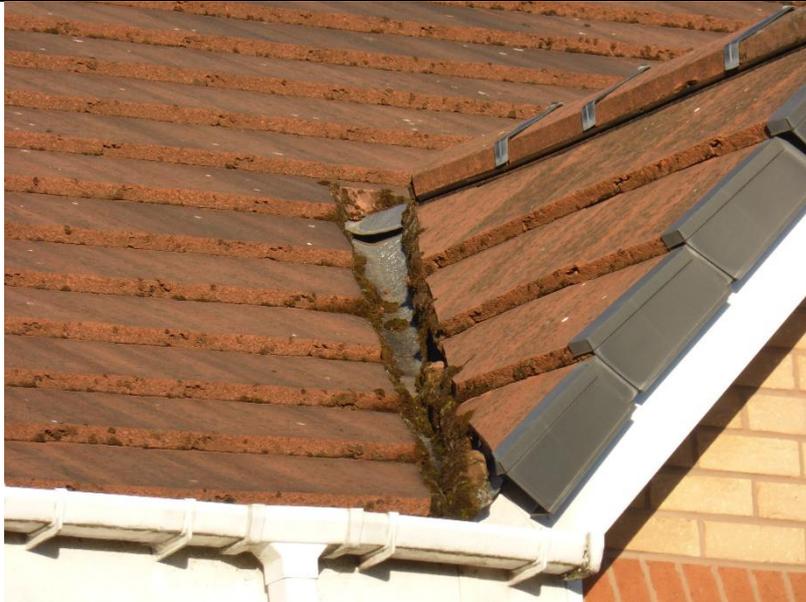
The main roof is covered with concrete tiles and I believe overall in good condition. However, The front valleys to the pediment require repair to the mortar pointing and remove the moss. The valley tray to the right hand valley has been installed with excessive overhang into the gutter, this is impeding the gutter and causing a blockage. One tile is loose adjacent to the right hand valley and a dry verge cover is loose to the left verge of the pediment

Loose mortar and a build up of moss

Main Roof – Repair valleys and remove moss

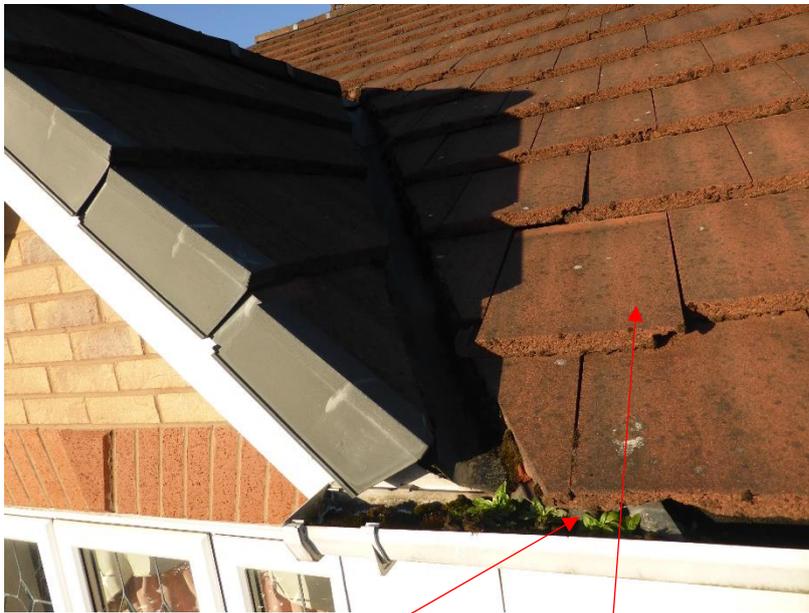
Valley tray requires shortening and tile re-fixing. Note blocked gutter

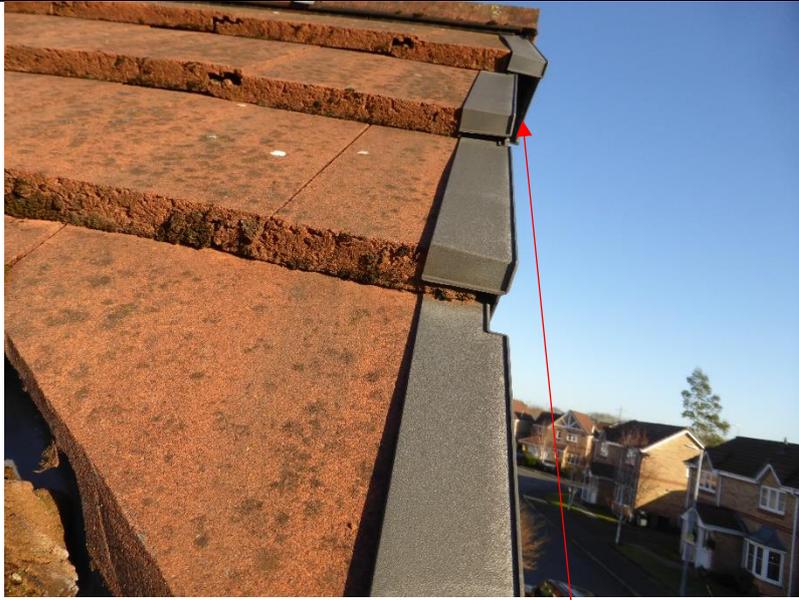
Dry verge is loose to front pediment

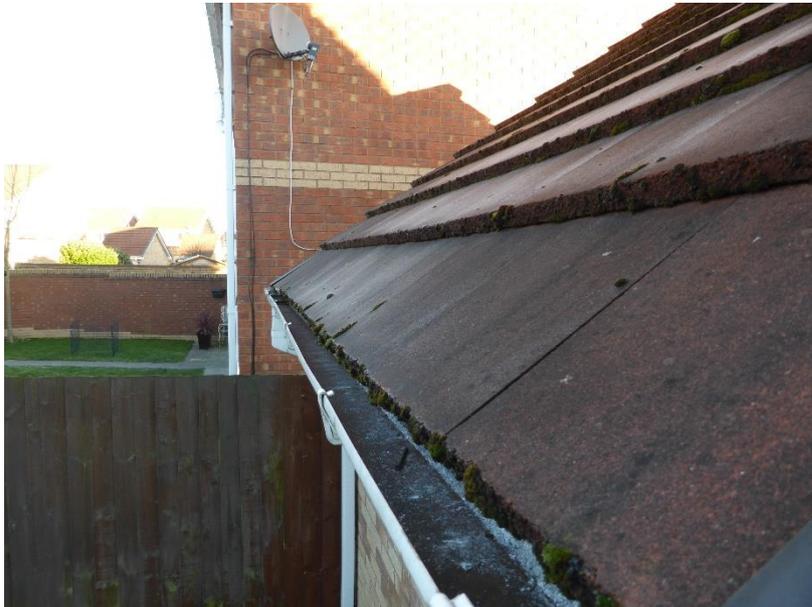
Blocked gutters holding water

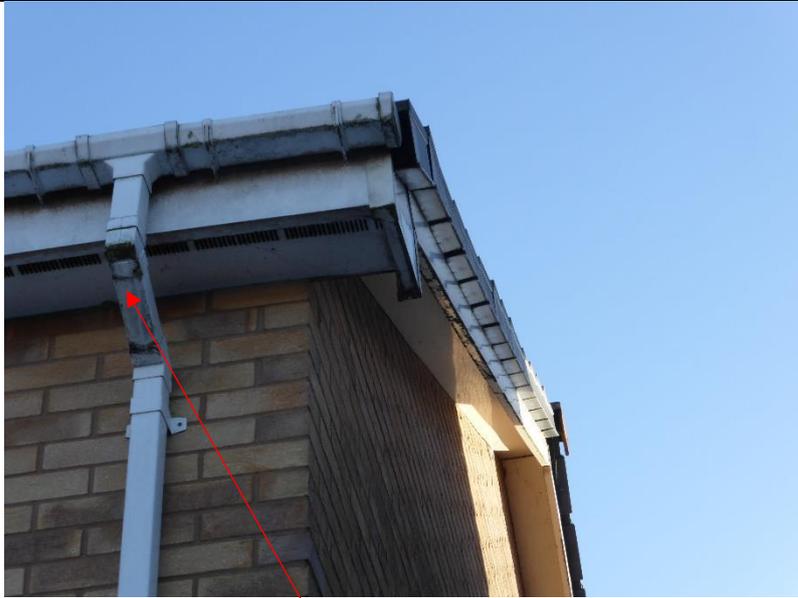
Rainwater goods are formed in uPVC and are generally in good condition. Guttering of this type is prone to leakage and does require regular maintenance to avoid water ingress and damage to internal finishes and services. As part of any future remedial works to the main roof, it is advised that all gutters are cleared and repairs undertaken to any displaced and leaking joints as necessary.

Gutters and rainwater pipes require cleaning and maintenance to the joints

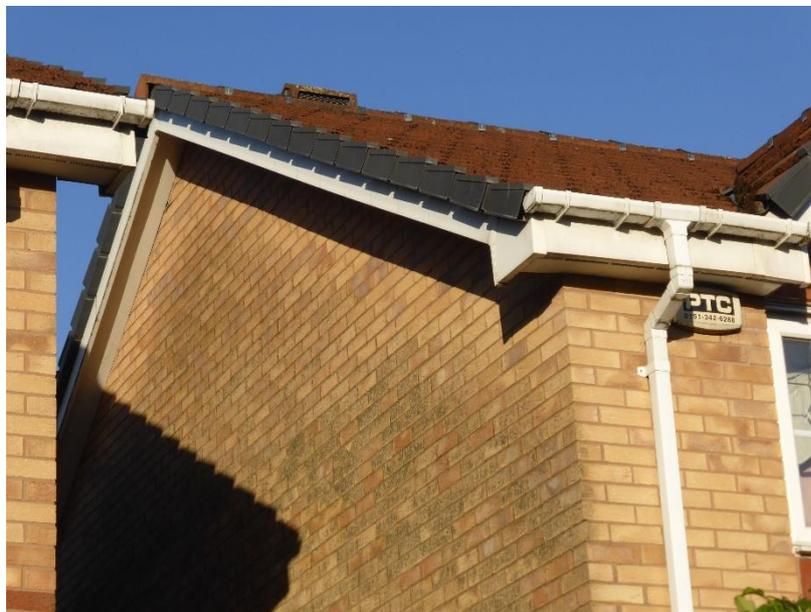
There is no sign of significant movement or deflection in the walls. The gable which is in close proximity with the adjoining property is sheltered and algae has appeared on the brickwork. Pressure washing is not advised as this will cause the bricks to absorb more moisture. Scrubbing with jeyes fluid removes the algae and inhibits regrowth.

Algae has formed on the sheltered SW facing gable end

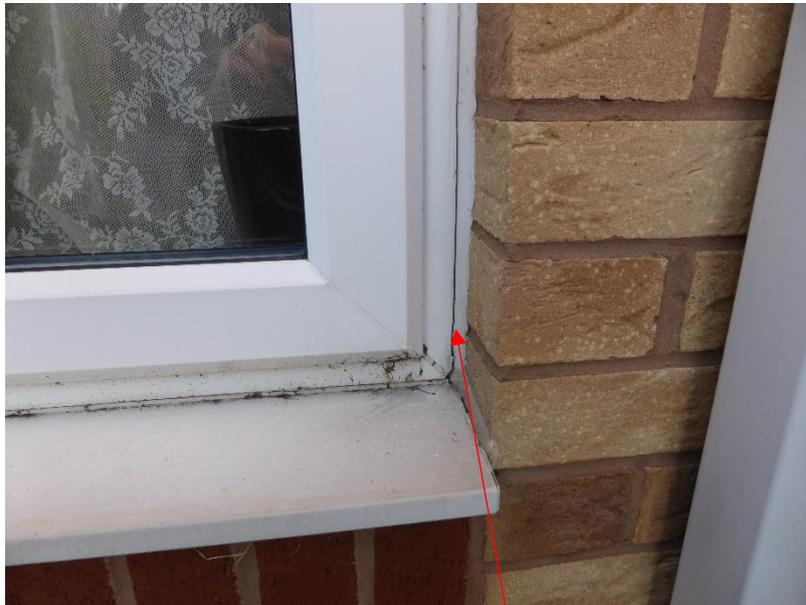
The windows require some attention to lubricate hinges, renew internal and external seals, service locks and tighten loose handles. Cleaning with a proprietary u-PVC cleaning product will prolong the appearance of the white - PVC.

Renew seals around windows and clean frames with proprietary PVC cleaner

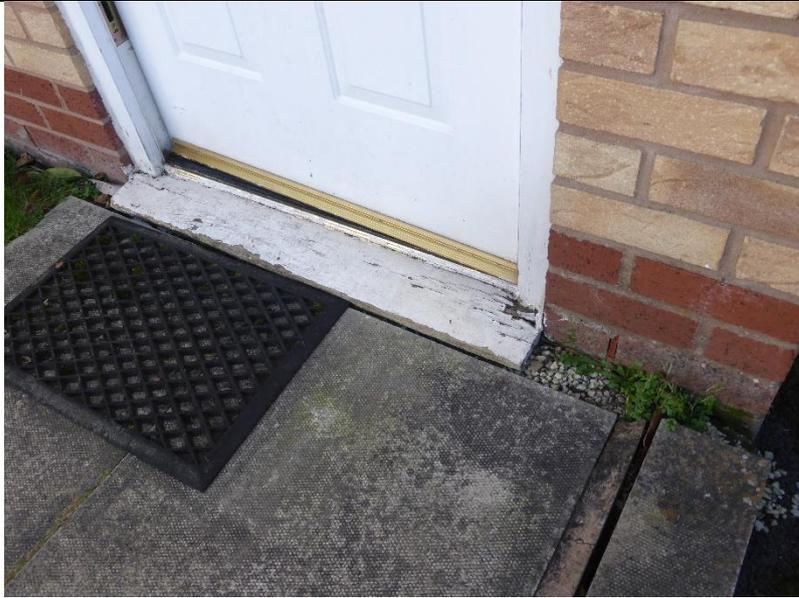
The front entrance door frame as a rotten frame which requires replacing, these door types are supplied as a kit and therefore the door may have to be replaced as it is integral with the frame. Adjustment to the door is required to reduce draughts. The rear entrance door is of the same construction and required decorating, the door is catching in the frame and requires easing. Both doors require new external mastic seals and draught seals.

Front entrance door sill is rotten

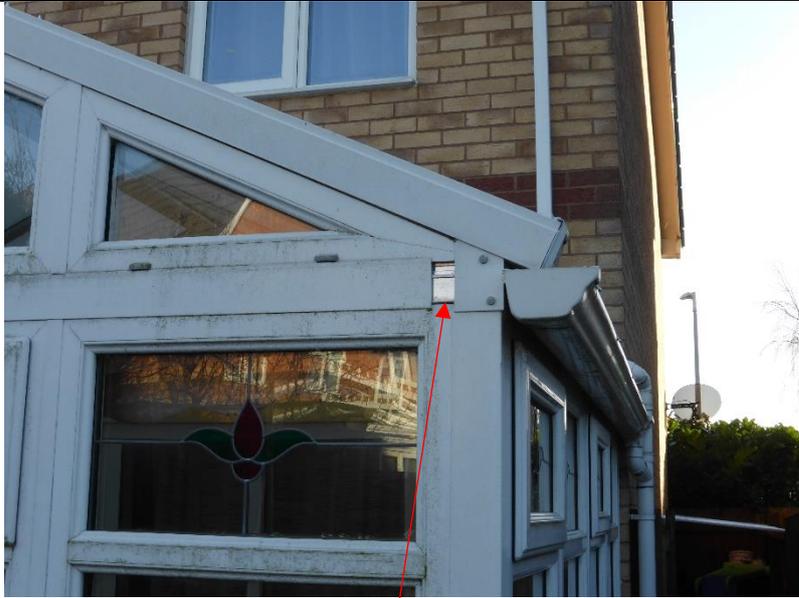
The conservatory requires maintenance work to replace missing plastic components including the roof tie bar boss cover and the external frame cover and also to clean moss and algae from the frames, roof and gutters. The French doors leading to the garden require adjustment and servicing of locking components to ease operation. This is a relatively old conservatory and safety glass kite marks were not visible, therefore it is assumed that the glass is not annealed or laminated.

Missing cover to aluminium frame

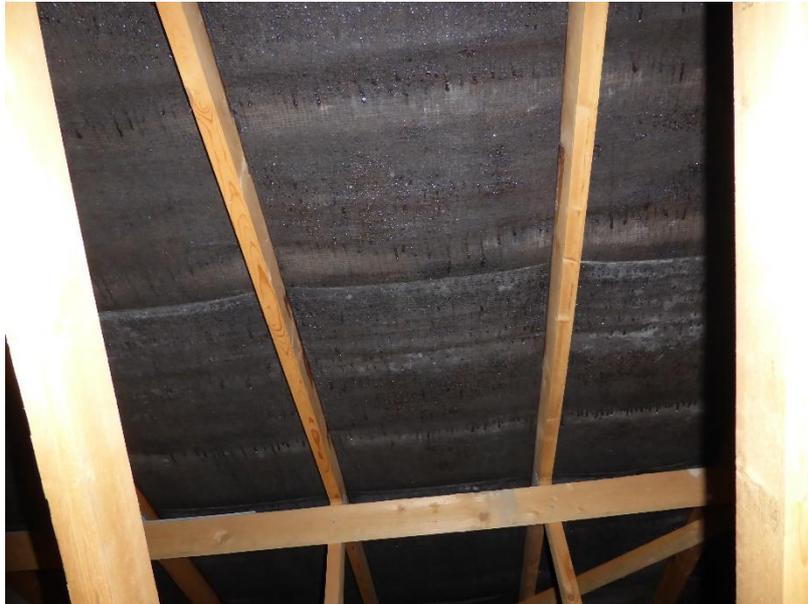
Timbers appeared to be in good condition. However, there is staining and saturation which indicates condensation within the roof space.

Condensate (the liquid formed by condensation) is clearly visible

Following the installation of loft insulation, the air in the rooms below becomes warmer, which means it can hold more moisture, absorbed from the normal human activities of cooking, showering, breathing and perspiring. This warm, moisture-bearing air then passes through the top-floor ceilings into the cool loft. A vapour barrier should be fitted on the "warm" side of the insulating material.

In the case of loft insulation, this could easily be done by draping a sheet of polythene loosely across the joists, before fitting the insulation.

Roof Structure – Condensation in the roof space. Replace en-suite extract fan and duct. Ventilate when cooking and bathing. Install a vapour barrier below the insulation.

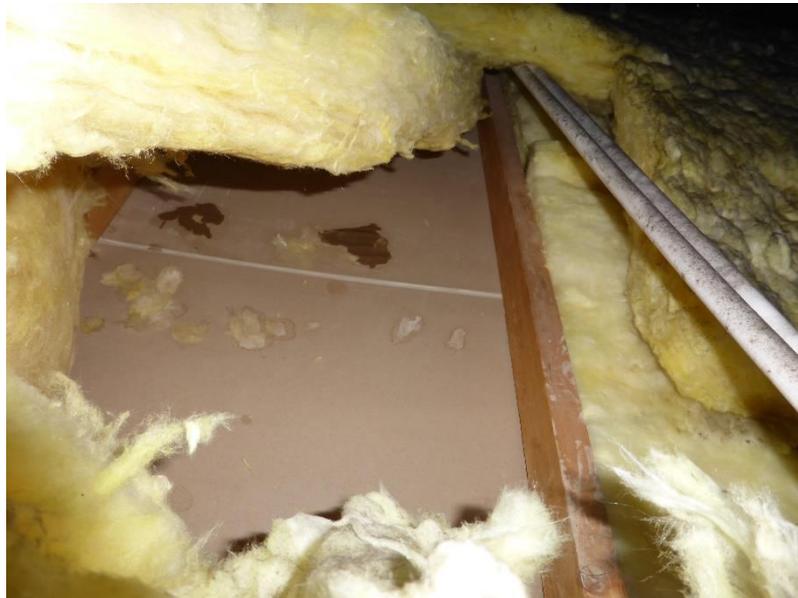
Saturated insulation is adding to the problem and is causing wet patches to develop on the bedroom ceiling below

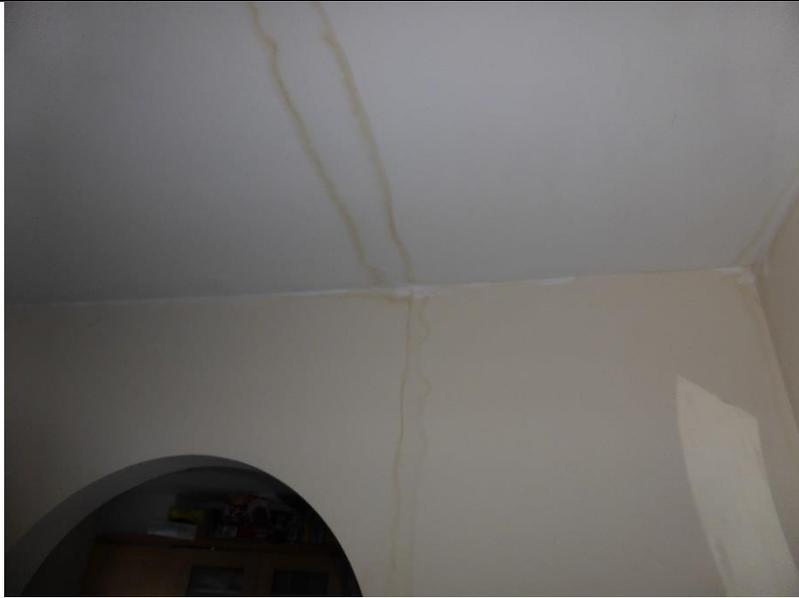
The ceilings are of plasterboard construction and in reasonable condition with few undulations or blemishes. However, repairs are required to areas affected by water staining to the ground floor from a leaking shower and to the second floor which is caused by saturated loft insulation. There are nail pops that require filling and painting.

Leaking shower has caused water staining to the ceiling in the lounge and dining room

En-suite – Rectify water leaks from the shower.

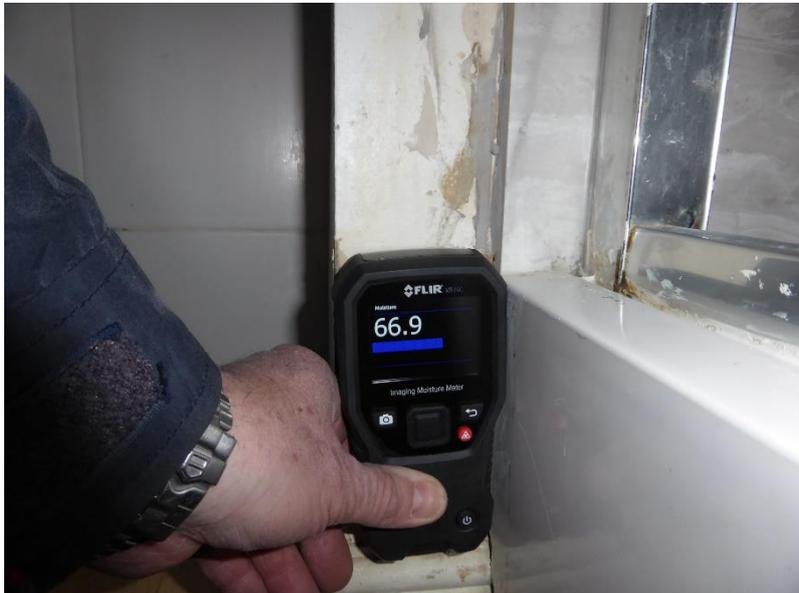
Zero moisture readings were recorded at ground floor level within the wall fabric. However, high moisture readings were recorded around the en-suite predominately around the shower area. The FLIR moisture meter penetrated deeper into the fabric than the standard pin meters and a higher reading with the FLIR is common.

Moisture within the wall fabric adjacent to the shower

There is high moisture content behind the shower tiles and around the entrance to the shower. This should be monitored as an issue and if the dampness persists further investigation is required to prevent lasting damage to hidden surfaces. Initially, the shower door should be checked for leaks.

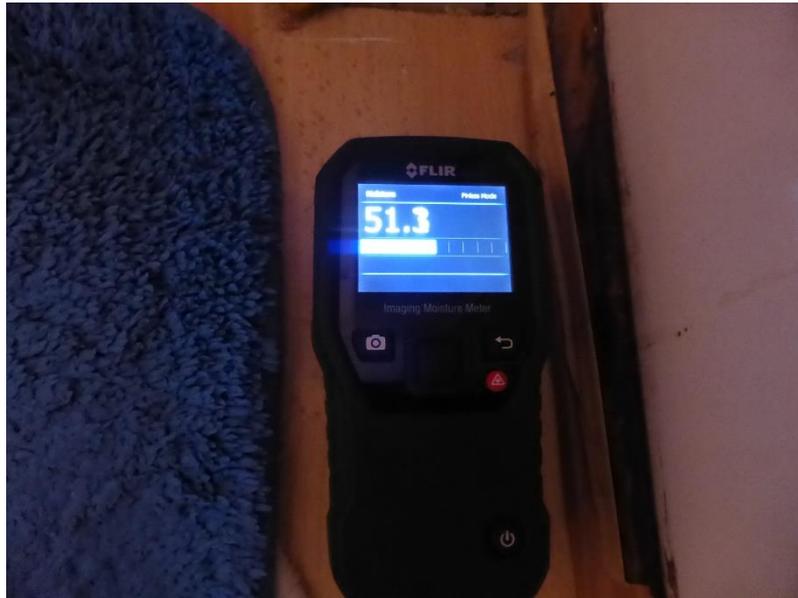
The en-suite floor recorded a high moisture content adjacent to the shower. This could be related to the shower door leaking. Further investigation is required.

High moisture content in the en-suite floor

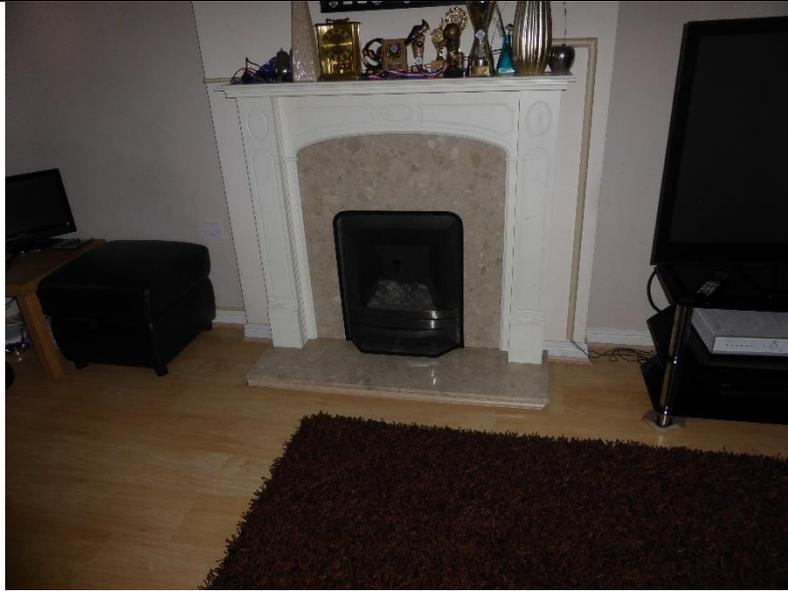
Gas fire should be tested prior to use

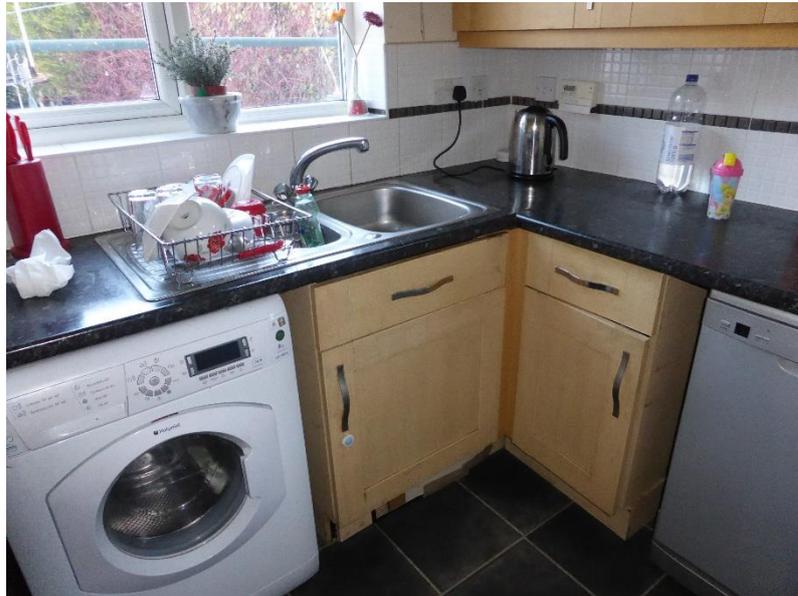
The kitchen fittings are dated but functional. Some repairs are required to kickerboards and general maintenance to doors. Due to the age of the components a replacement kitchen may be considered.

Dated kitchen units

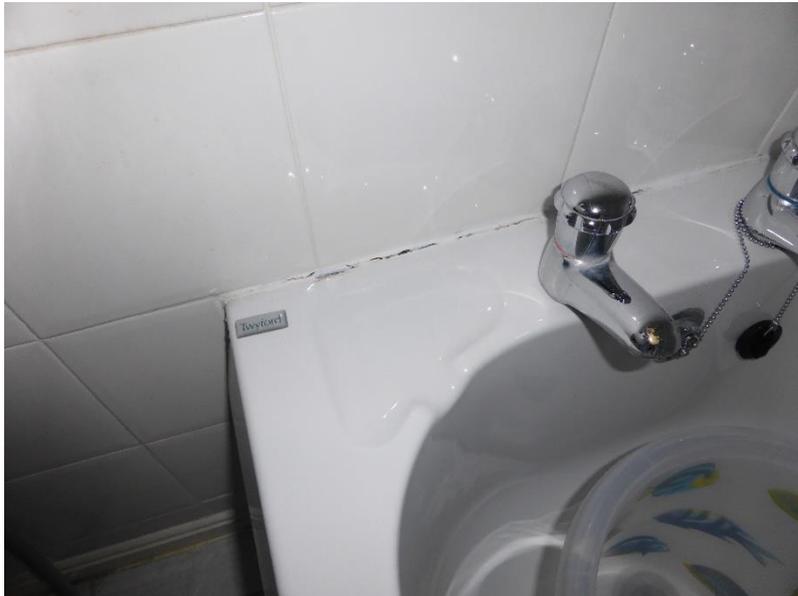
The bath taps are tarnished and loose and silicone around the bath is beginning to become mouldy.

Taps are tarnished and loose.

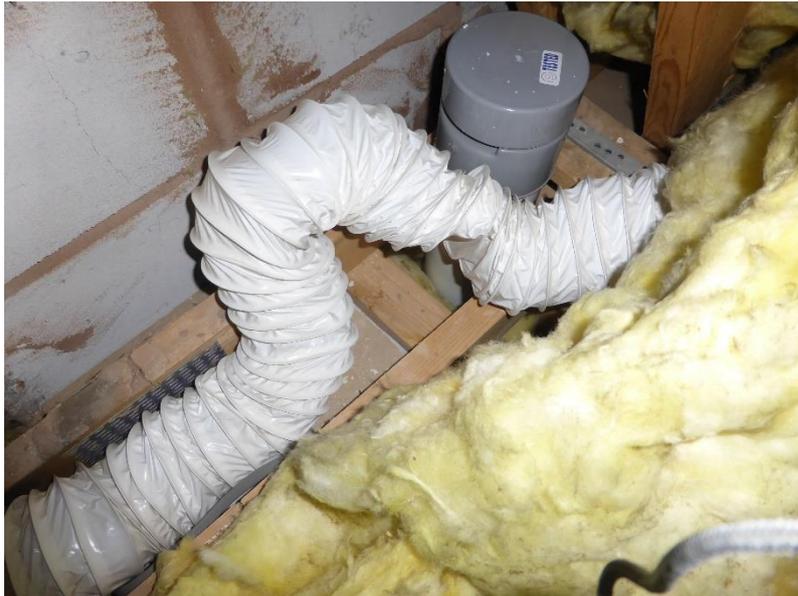
The extractor fan in the en-suite is very noisy when operated and is therefore isolated and out of use. Also, the flexible duct from the extractor is damaged which will restrict the efficiency of the fan. A new high performance fan connected to a semi flexible or rigid duct pipe will remove excess moisture during showering and the stronger duct pipe will prevent the pipe from being crushed under the insulation.

Duct pipe should be straight and undamaged for maximum efficiency

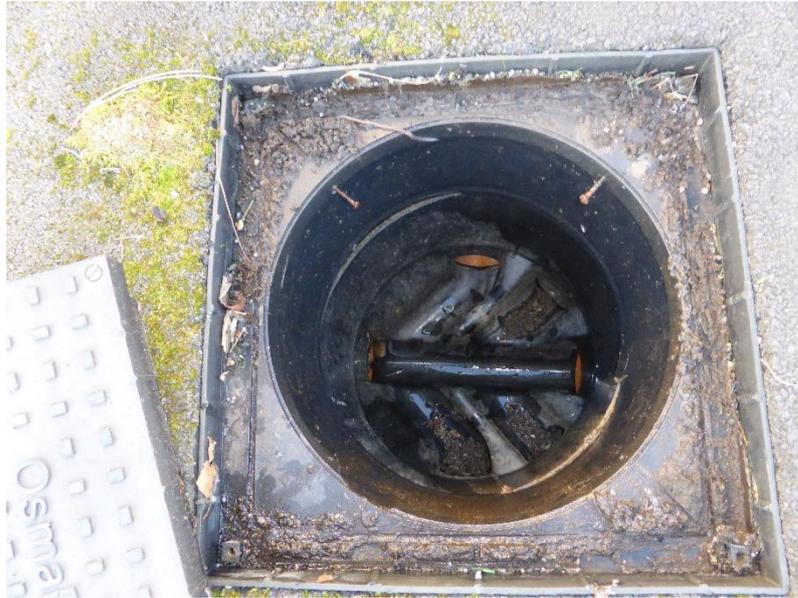
Drainage is assumed to be connected to the mains sewer outlet. Your Legal Adviser should check the arrangements for maintenance and repair with the local authority (see Section I3). I inspected the surface water drainage and found it to be clear of obstructions. The inspection chamber in the rear garden which is assumed to be the foul drain could not be opened due to a seized screw.

Surface water drain located on the front driveway is clear

I would recommend that the drains are located and inspected as necessary.

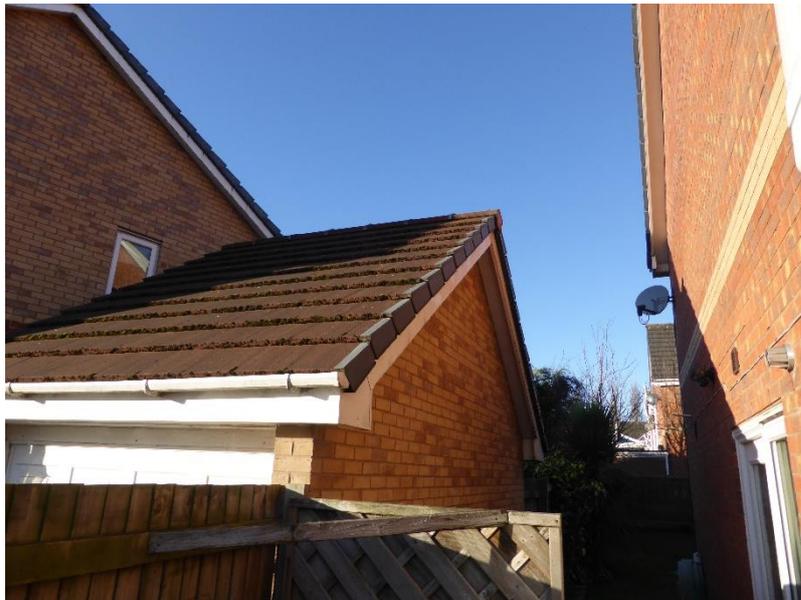
There is a brick built garage with a pitched roof covered with concrete tiles. The garage has an up and over door and a secondary single exit door to the side elevation all elements are in good condition. However, the roof and gutters will require regular maintenance to clear moss and clean the u-PVC.

Moss beginning to form on the garage roof

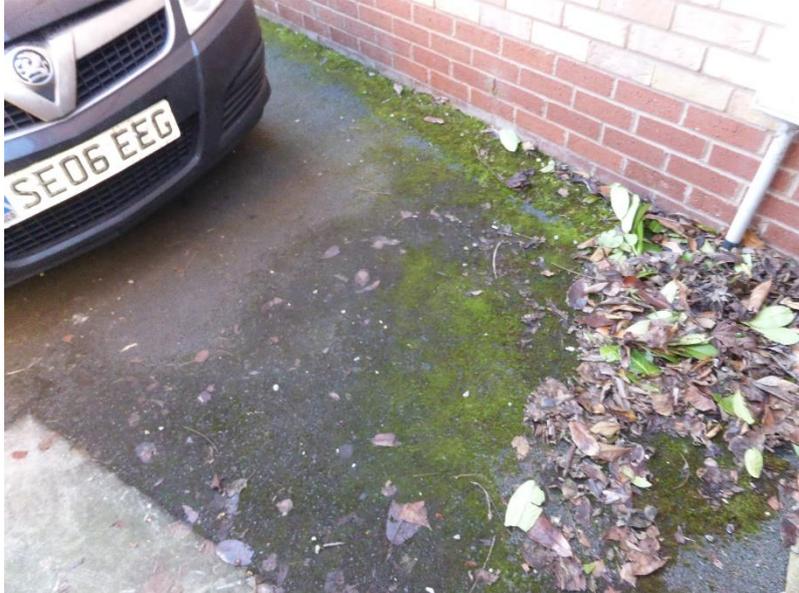
The plot has a macadam driveway that is in good condition. However, the driveway requires some day to day maintenance. Macadam driveways have a limited lifespan depending upon usage. There are also stone chippings around the rear of the property that will require treating with weed killer on a regular basis. The perimeter fence bounding the rear garden is a timber close boarded fence that will require regular maintenance.

Moss and algae growing on the macadam driveway
