Les Yates Surveys Ltd

# Survey level two: HomeBuyer report - Survey

xxxxxxxxx Avenue

xx March 2018

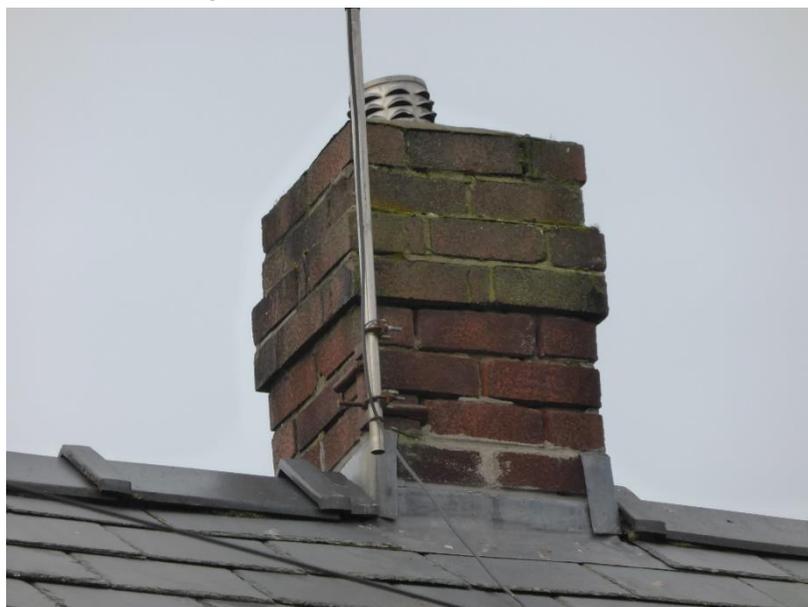
Recent work to replace the flashings and mortar did not address the missing mortar to the brickwork. Therefore, the chimney requires repointing.

Chimney requires repointing.

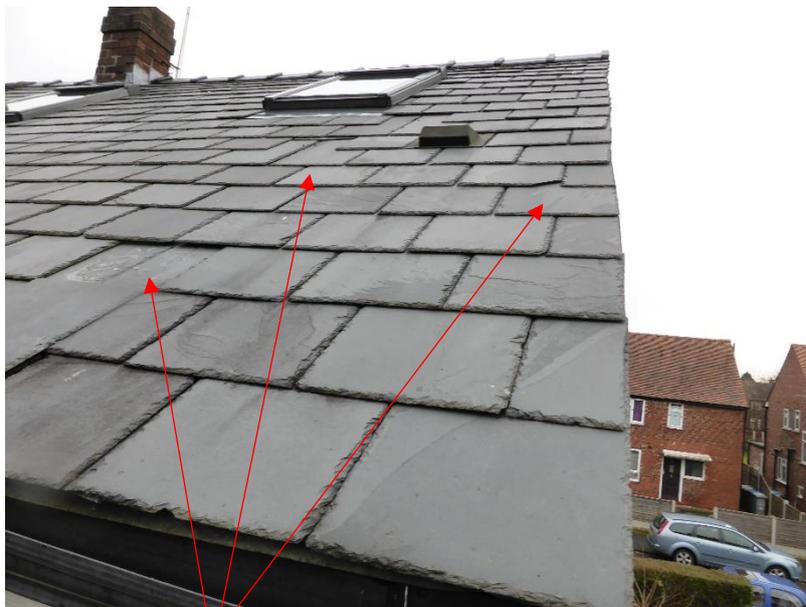
Imported slates or composite tiles are sometimes more brittle than Welsh slate or concrete interlocking tiles and in this situation, many have cracked or broken. Many damaged slates are visible and it is expected that more will materialise at a later date. Accessing these roofs for maintenance or aerial installation invariably causes more damage.

Some of the slipped and broken tiles to the rear elevation.

Removal of loose slates is urgent to prevent them falling and causing injury to people (J3 Risks to people) or damage to property.

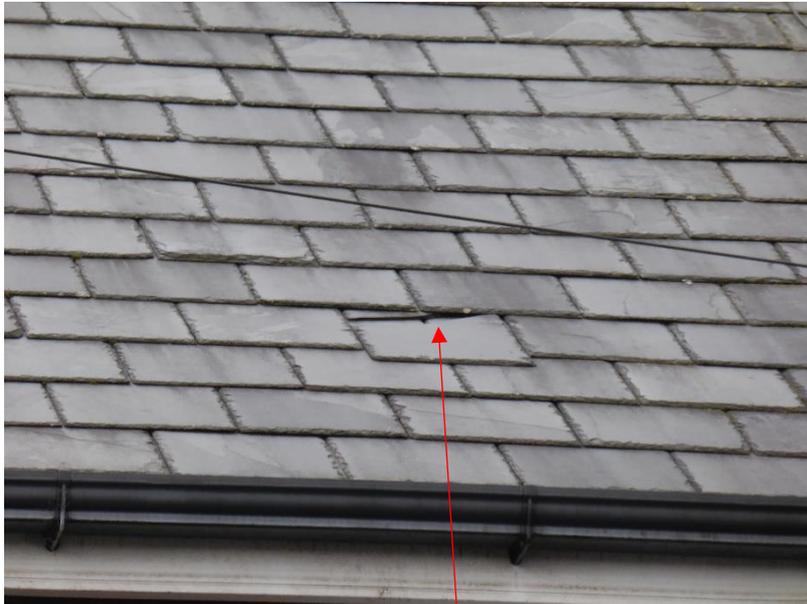
A cracked tile to the front elevation

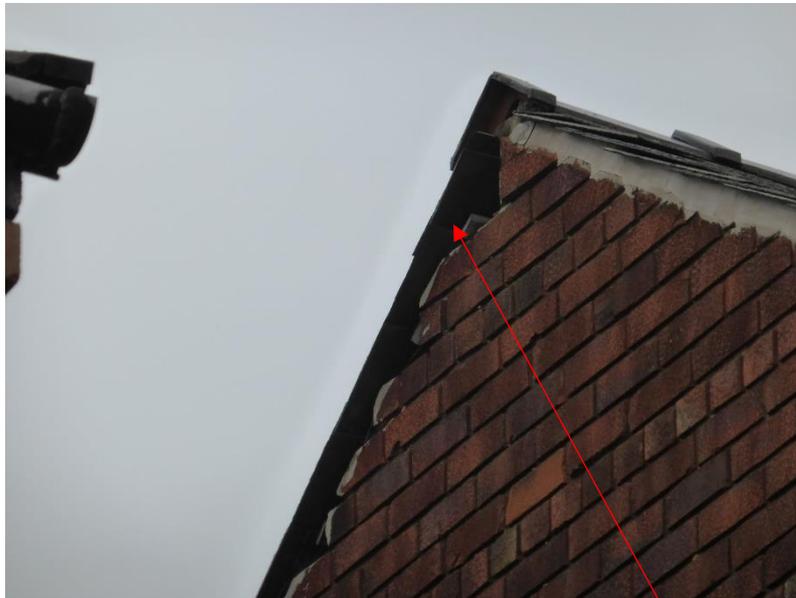
The underside of the roof is not sealed to the gable brickwork

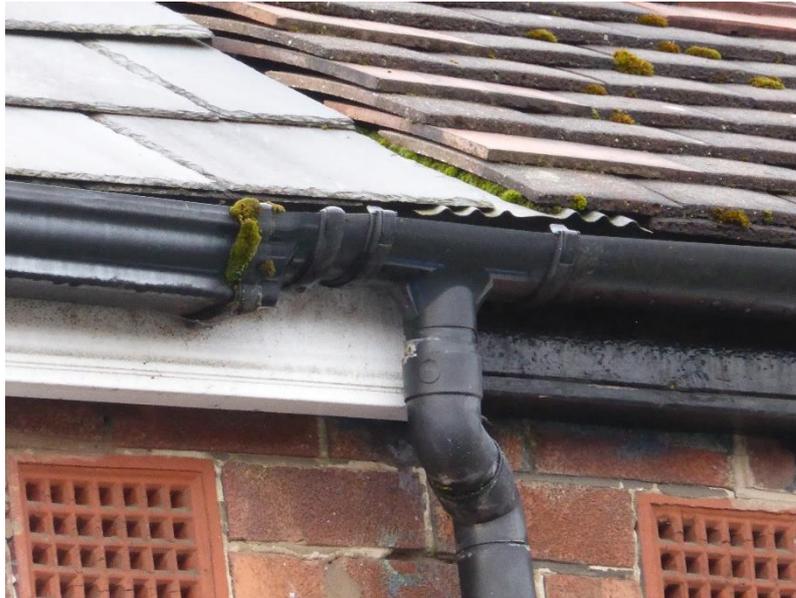
Rainwater fittings comprise PVC construction. The rainwater fittings appear to be serviceable at the time of the inspection, though it was not raining heavily and we cannot fully confirm this presumption. However, the union with the adjoining property is higher than the outlet and appears to be leaking, this should be resolved as a matter of urgency to prevent overflowing rainwater cascading down the external walls which can lead to saturation of the cavity insulation and internal wall dampness.

The two gutter types may be incompatible in this particular application

Guttering of this type is prone to leakage and does require regular maintenance to avoid water ingress and damage to internal finishes and services. As part of any future remedial works to the main roof, it is advised that all gutters are cleared and repairs undertaken to any leaking joints as necessary.

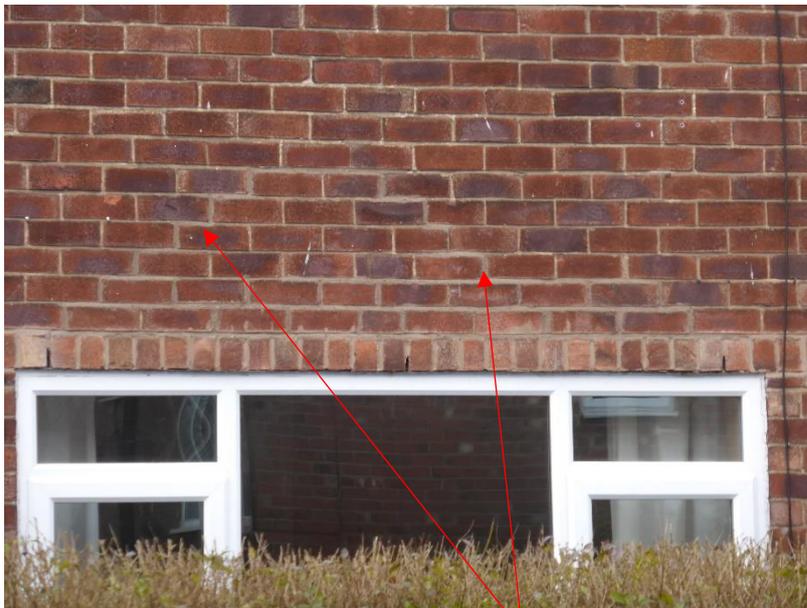
**Evidence of cracking above the window. Note stepped mortar pointing forming an inverted 'V' and the header course is not level. The brickwork appears to be relatively stable**

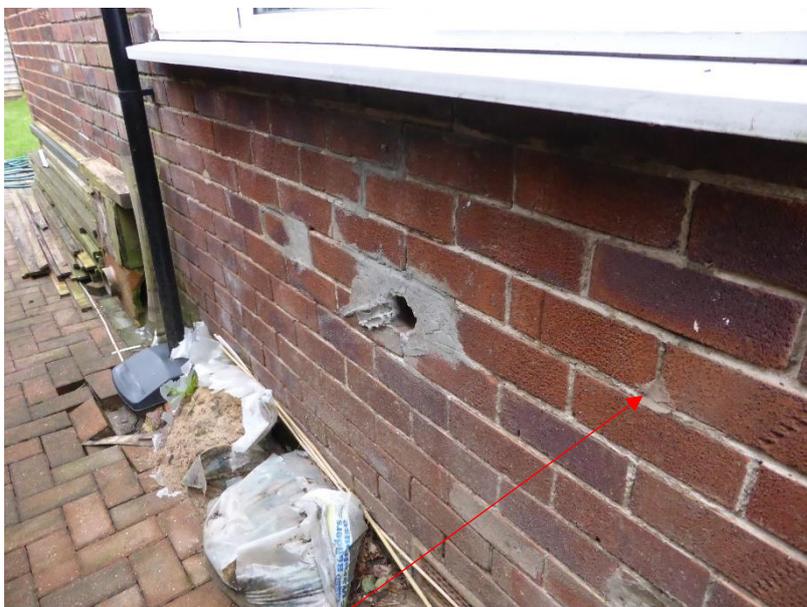
**Evidence of injected insulation, note the untidy repairs and an open penetration**

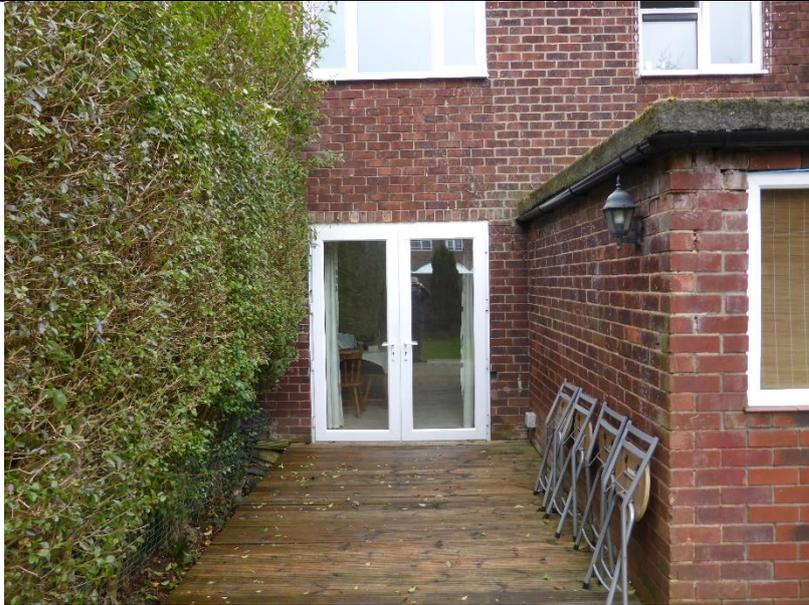
**The presence of a lintel above the patio doors could not be established. The brickwork is stable**

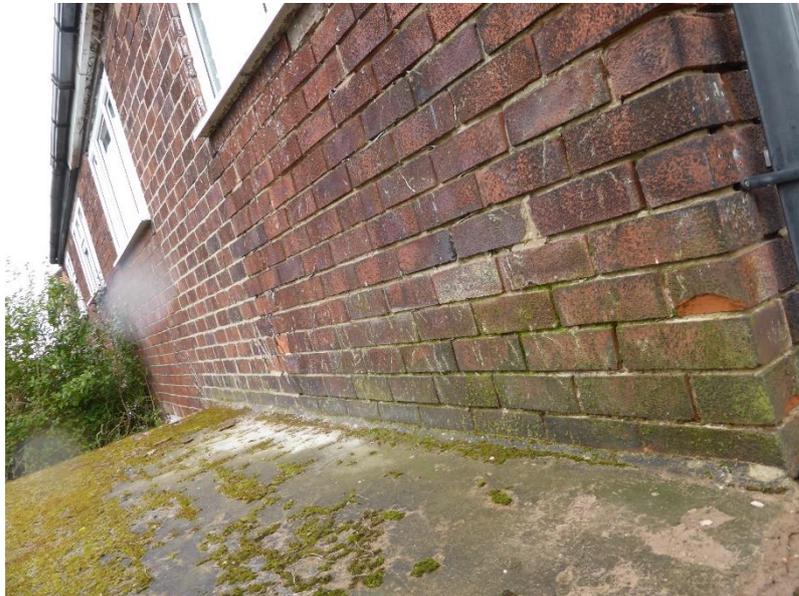
The brickwork has been patched and altered in many areas and there is missing and spalling brickwork around the property. New pointing is localised only and many areas require repointing and replacement of spalled and missing bricks.

**The brickwork requires pointing to eliminate the patchwork appearance and weatherproof the brickwork.**

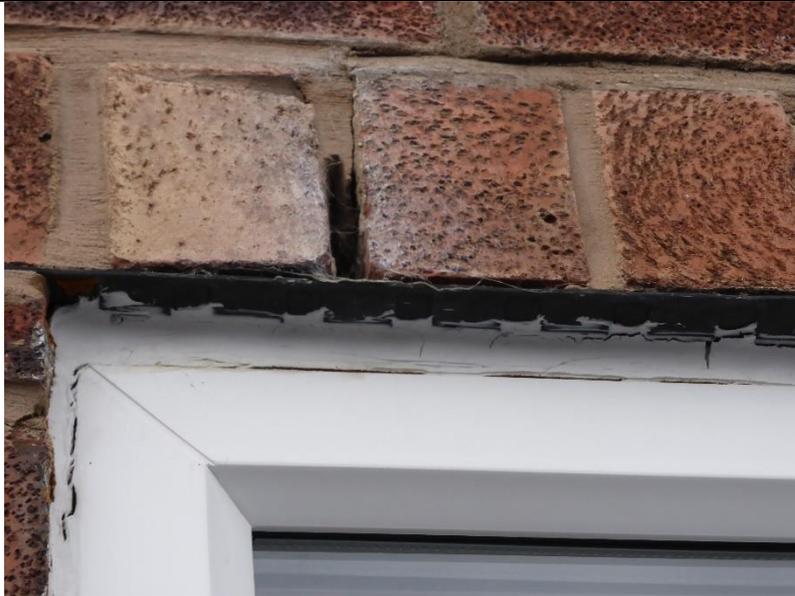
Plastic trays or liners have been installed above the windows and patio door, this is known as a cavity tray. Evidence of steel lintels and the correct installation of cavity trays should be provided by the vendor. A budget cost for installing lintels where required is £1500. Brickwork pointing and repair is not urgent. However a budget cost for this work is £3000. Holes in external walls should be filled to prevent vermin nesting in accessible cavities.

Plastic tray above the lounge window frame. A lintel is not visible

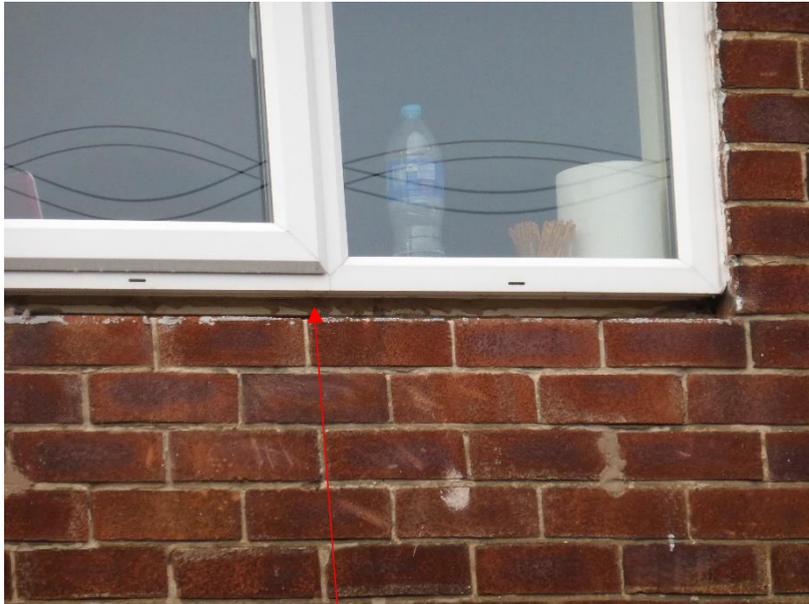
**Front bedroom windowsill missing**

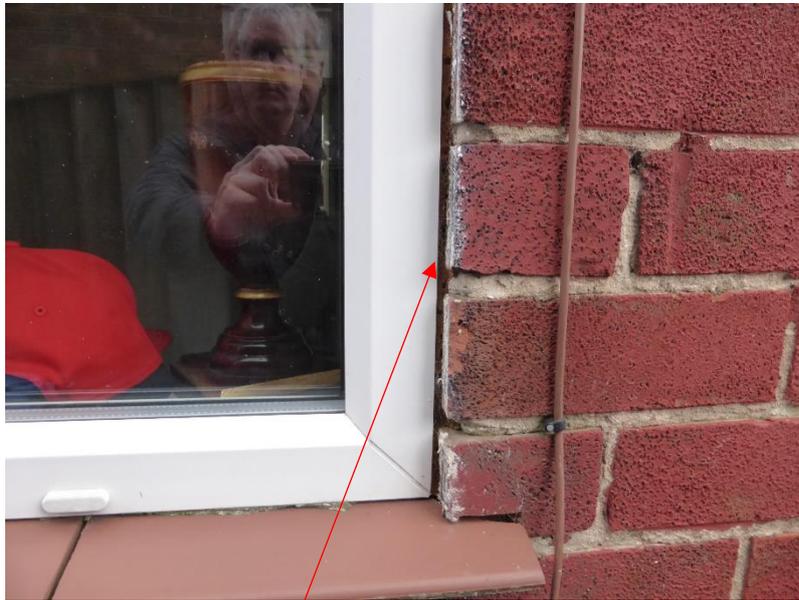
The window frames are of uPVC construction with sealed double-glazed units. Some areas of external perimeter frame seals were found to be in need of renewal and in some cases the seal is missing entirely exposing the expanding fixing foam. Damp can easily penetrate around the edges of window (and door) frames. To minimise problems, it is essential that the frames are kept in good repair and carefully sealed to the walls.

**Sealant missing to the frame edge**

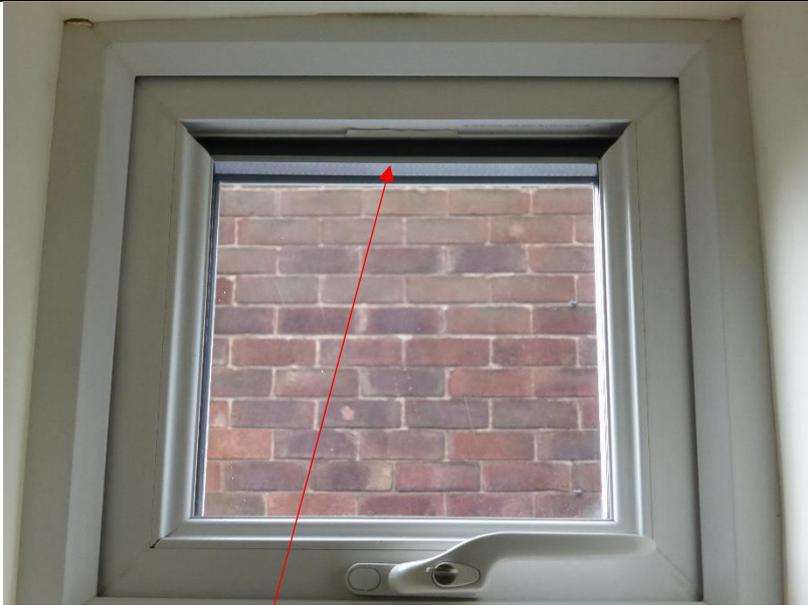
Landing window glazing bead missing

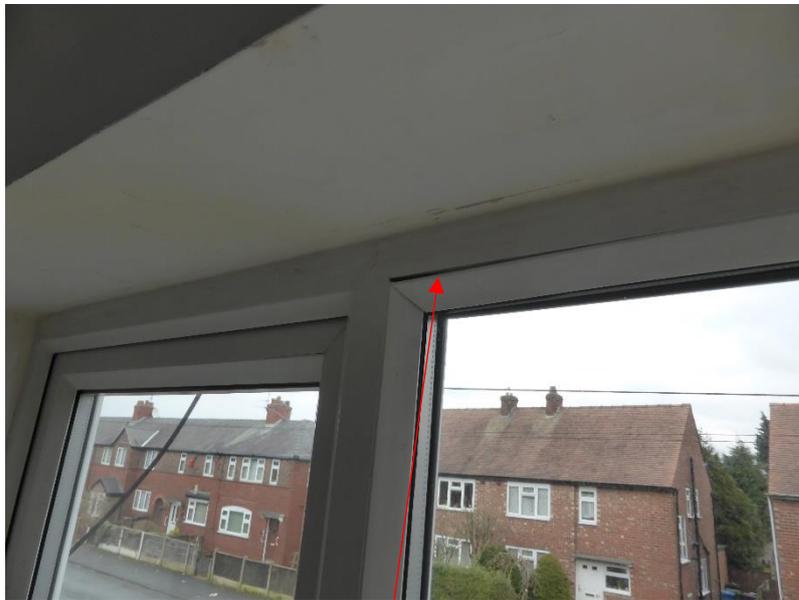
Loose glazing bead

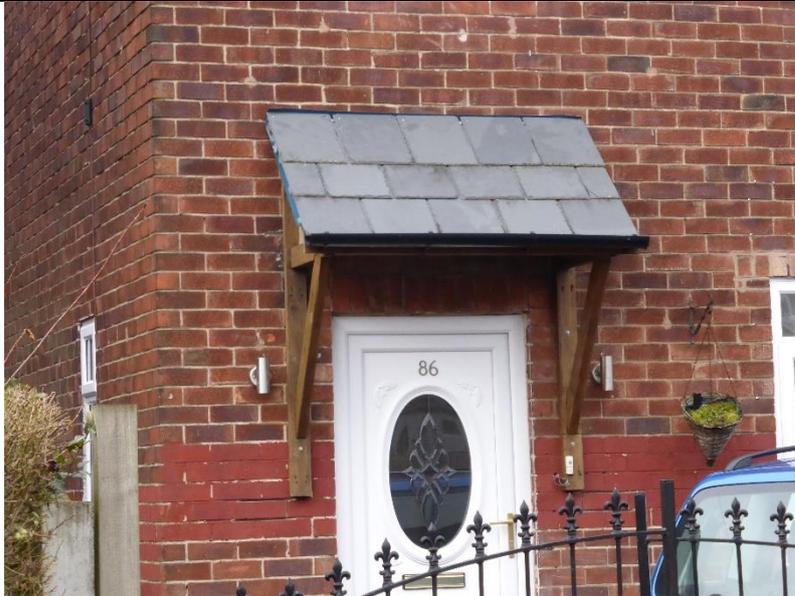
Lead flashing and pointing to the tile edges is required

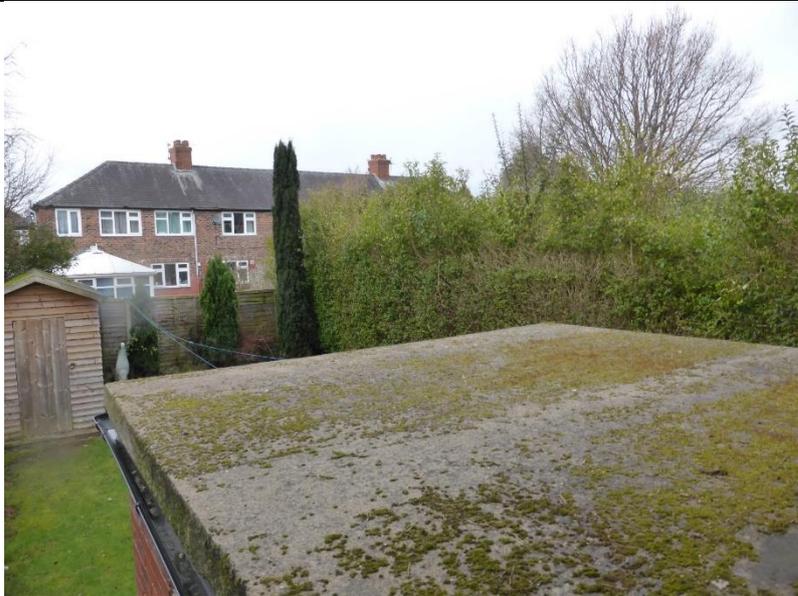
The concrete flat roof to the outhouse is porous and covered with moss and algae. This roof will absorb water and leak unless a covering is applied. If this part of the property is to be used as part of the main dwelling a GRP (Glass Reinforced Plastic) roof could be applied which is a durable and cost effective covering for this type of flat roof. A budget estimate for this type of roof is £700 depending upon the system used and the contractor.

**The concrete flat roof is covered with algae and is porous.**

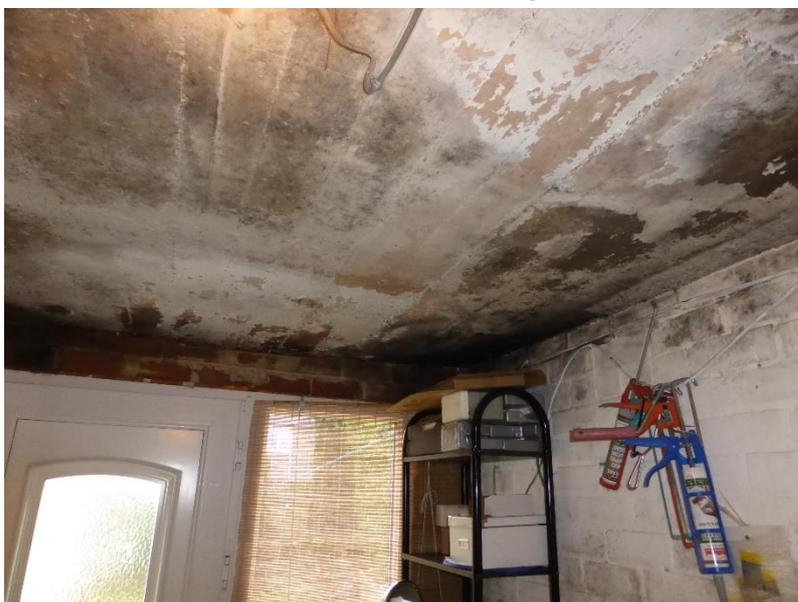
**Single skin walls and damp ceiling**

Internal walls require an insulated inner leaf, the concrete floor should be inspected and replaced if it is excessively damp or there is heave or spalling and the soffit (ceiling) insulated and plastered.

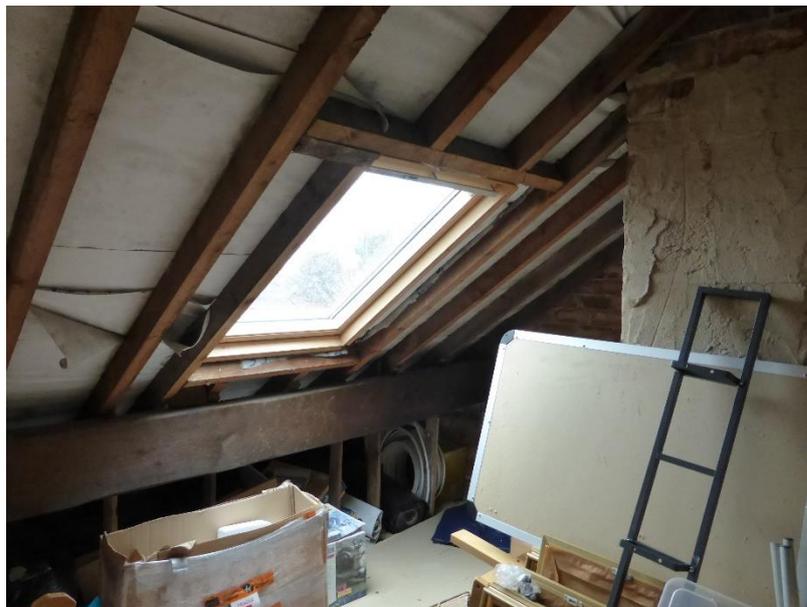
The roof structure is dry and no defects were visible.

Roof structure is In good condition

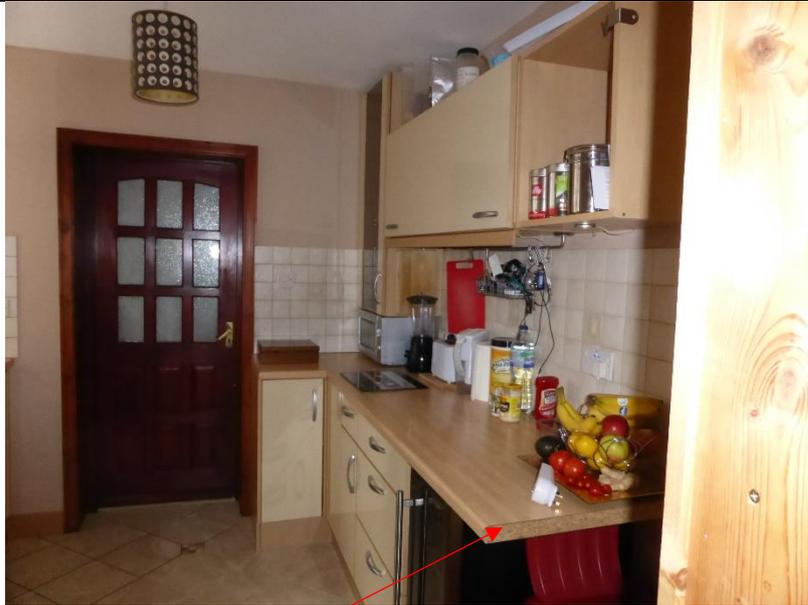
Note the edging is missing. Door and pelmet not fixed

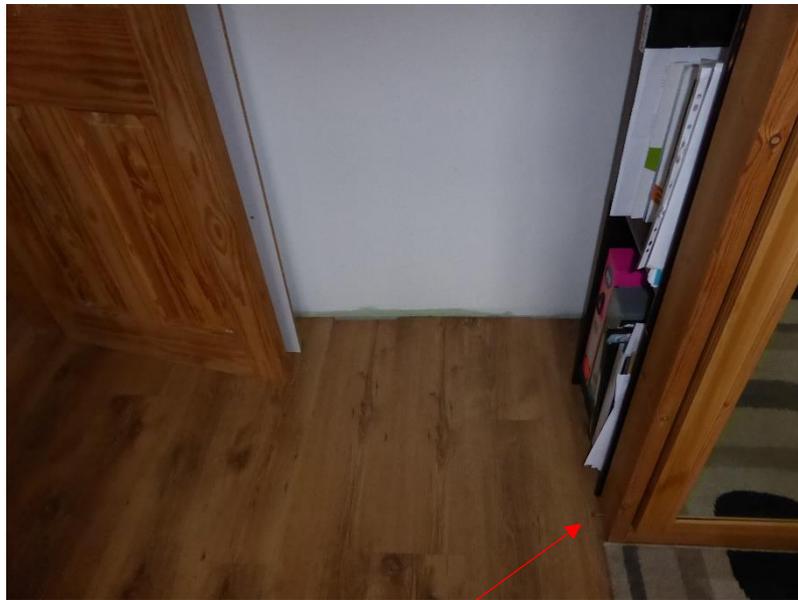
Note projecting screw from the frame and unfinished end detail

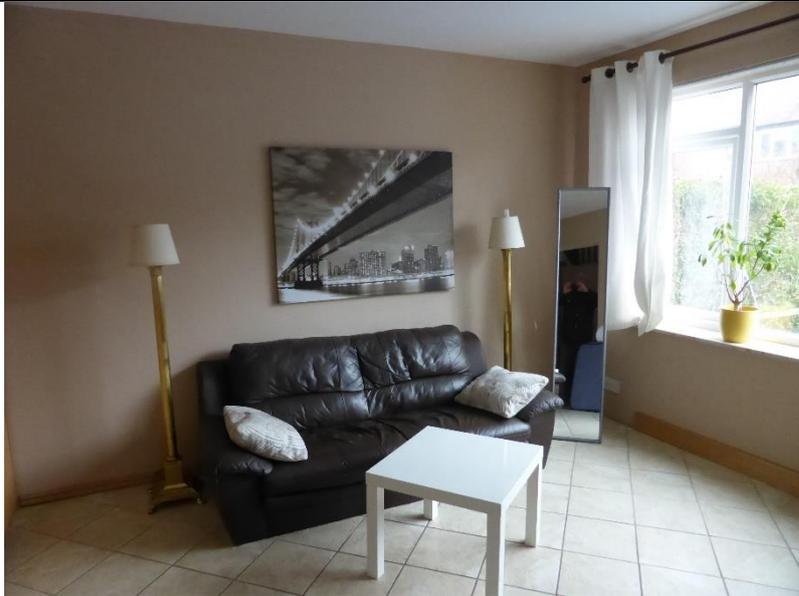
Joinery throughout is mismatching and unfinished

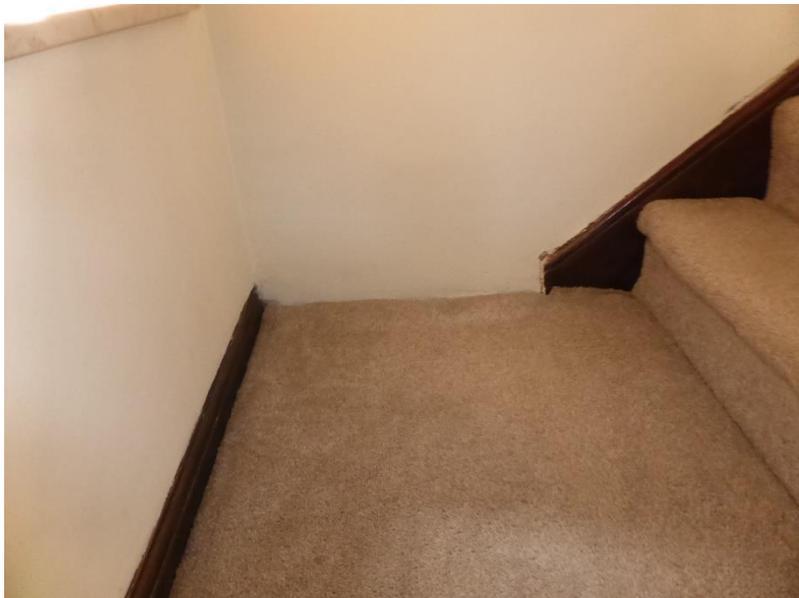
Skirting missing on the stairs

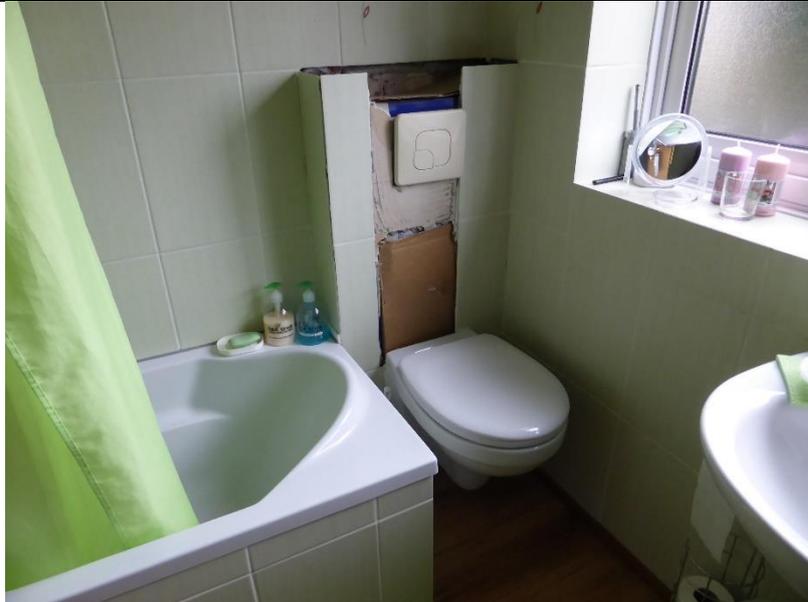
The bathroom has a bath with a mixer shower and tap and combination, there is a W.C and a wash basin. The fittings are generally servable. However, the toilet cistern required repair and tiles were damaged in the process and the bath requires resealing with silicone sealant.

Tiles missing from back to wall toilet unit

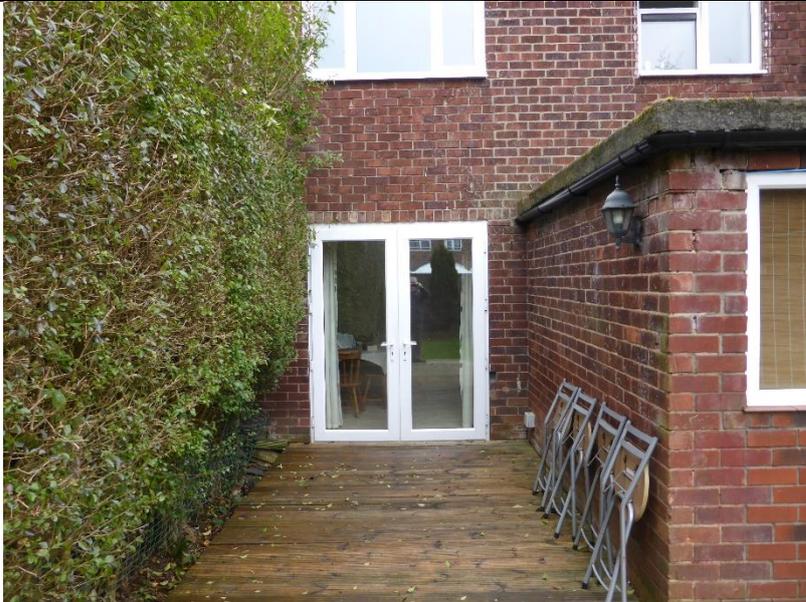
**The decking planks sink when walked upon**

Decking – remove or replace decking

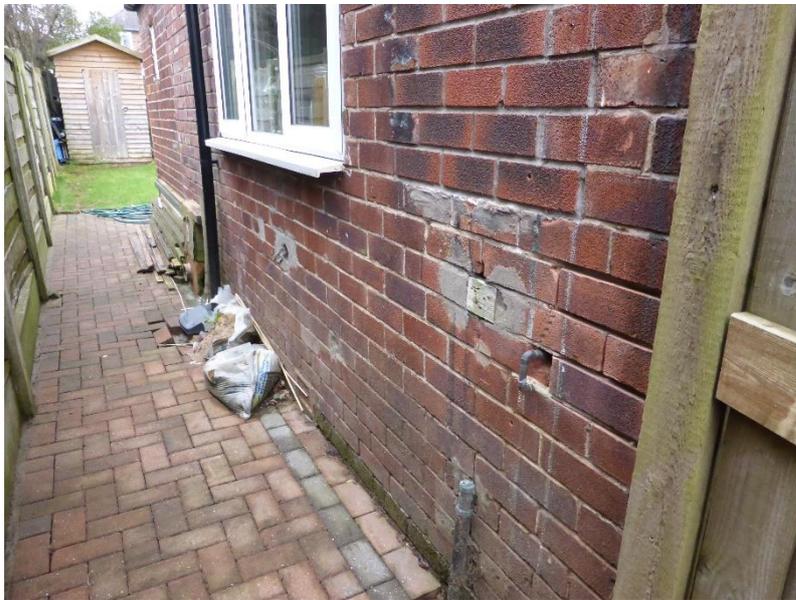
**Block paving loose around the gully**
