Survey level two: HomeBuyer report - Survey

Stickens Lock Lane

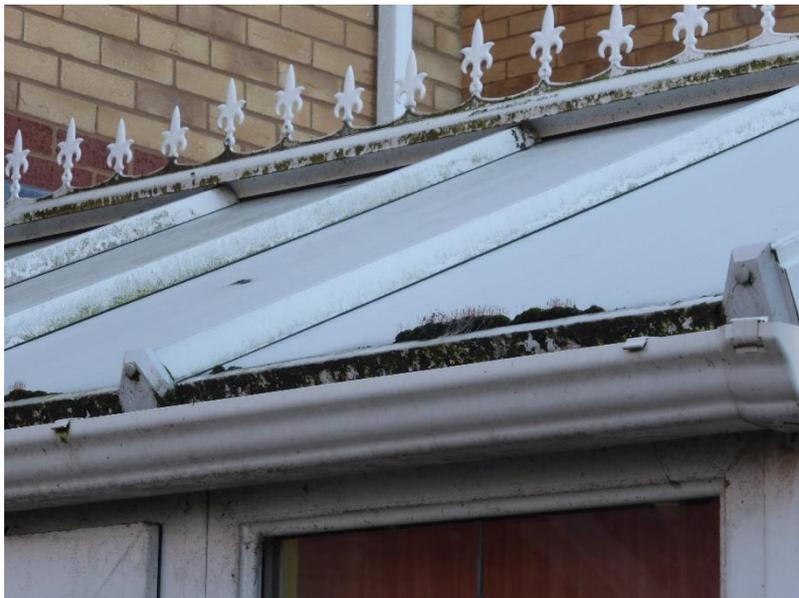
The conservatory requires maintenance work to replace missing plastic components including the roof tie bar boss cover and the external frame cover and also to clean moss and algae from the frames, roof and gutters. The French doors leading to the garden require adjustment and servicing of locking components to ease operation. This is a relatively old conservatory and safety glass kite marks were not visible, therefore it is assumed that the glass is not annealed or laminated.

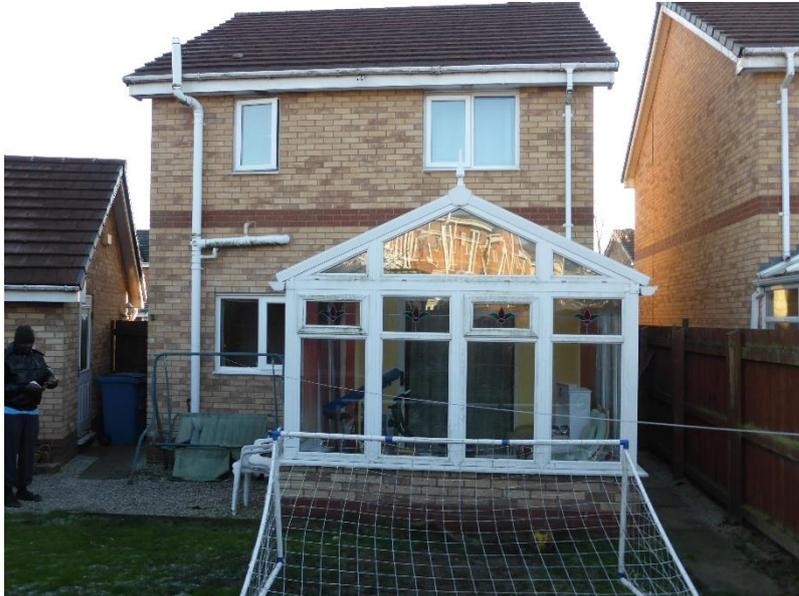
Lawned rear garden
