Les Yates Surveys Ltd

# Survey level two: HomeBuyer report - Survey

xxxxxxxxx Avenue

xx March 2018

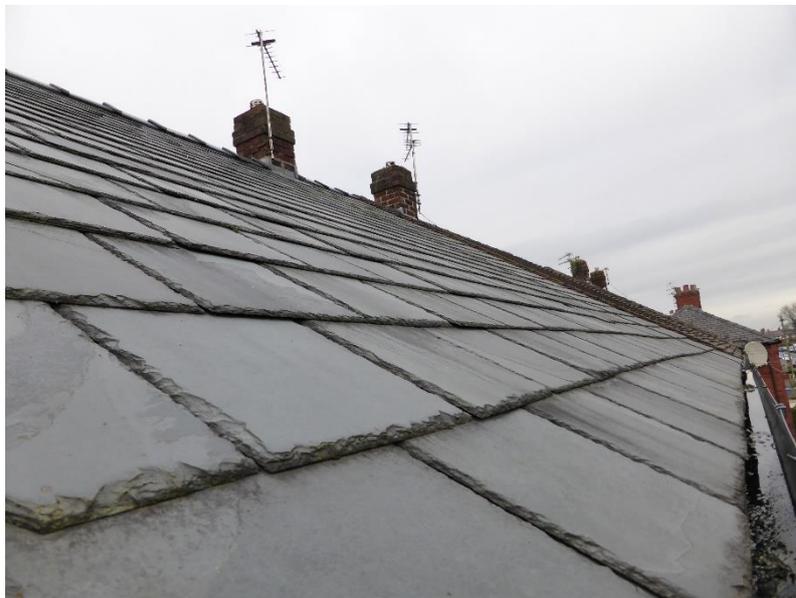
The two gutter types may be incompatible in this particular application

Condition rating 3

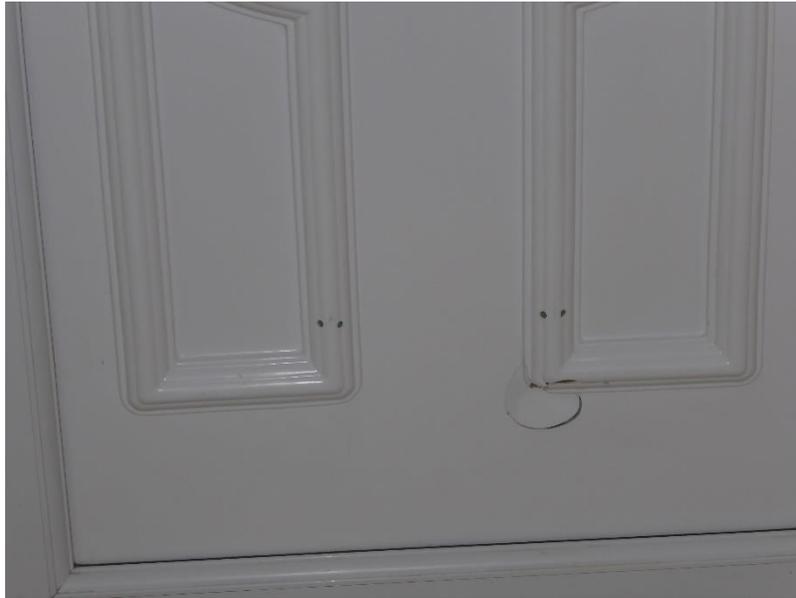
The front entrance door panel is damaged, repair is difficult and a replacement panel may be required. Replacement panels vary in cost depending upon quality. These can cost approximately £300 fitted. All doors require adjustment and lubrication to ease operation.

**Condition rating 2**
